**Why batteries used in Underground Safety Refuge Chambers fail prematurely**

**Case Study** - MinaArc 1367 Safety Refuge

**Case Study** – Strata 12 man Refuge Chamber

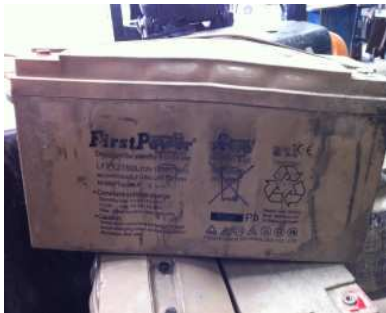
In February 2012 we were approached to source batteries for use in underground refuge facilities. We were provided with a photo of the sample (see below) and was told that this sort of problem was common in all refuges. At first glance it looked like the batteries had been overcharged but without visiting site to inspect the facilities there was no concrete reason to suspect this, as the prevailing opinion was that high operating temperatures was the probable cause the batteries where failing. We began by looking at alternative battery types eventually settling on the EnduroGel from Power Charge. This decision was made on the basis of its higher tolerance of temperature, its "Catalyst" technology, longer design life and because it came highly recommended. We supplied the Enduro's for a couple of years without any feedback and assumed the change had been positive for the mine and was were surprised when in early 2015 we received a call from the mine querying the quality of the Enduros because of their high premature failure rates. The Enduro's had suffered the same fate as their predecessors but at a faster rate and we became suspicious of the refuges charging systems. It was only after we began supplying another mine with batteries that we realised there was a serious problem with how the electrical system had been set up in the Refuge Chambers. Recently we have had the opportunity to investigate.

Destroyed Battery

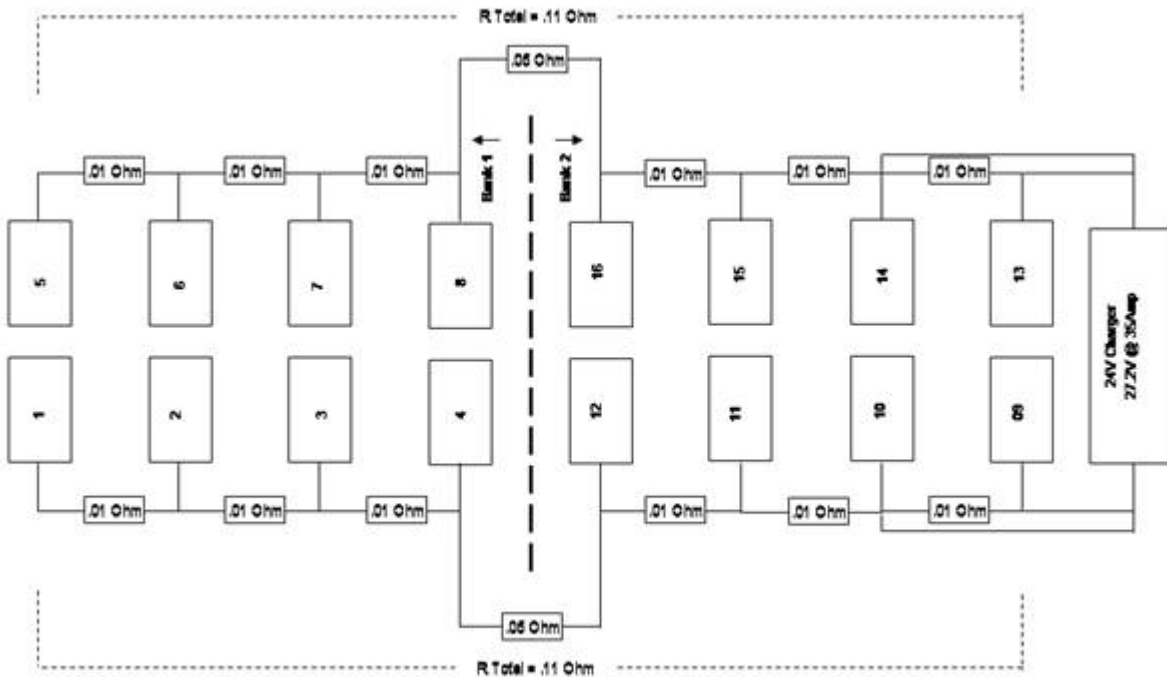
Fig 1

The batteries (16 x RITAR RA12-150) were all in an overly discharged condition with cell numbers 10,12,14,16 (Refer diagram below) completely destroyed. Temperature of batteries was 30.1 Deg C  
The charger installed was a Magellan 24Siii035. A 35 amp float charger set at 27.2V  
The estimated age of the battery bank is 25-26 Months as of January 2016

In this instance 16 batteries were being charged at the top of a string of two paralleled banks. However, at the bottom of bank 2, two long paralleling cables were connected to cells 12 and 16 joined cells 4 and 8 in bank 1 (see fig 1) essentially forming a single 24V bank. It is unlikely that these paralleling cables were fitted by the manufacturer and may have been added later. It is also questionable whether this particular charger would have contributed to premature failure.

The interconnecting cables are essentially resistors albeit of a very low value. As a consequence of this resistance the batteries in 1 would never have charged at the same rate as the others in bank 2 and therefore would never have received their proper share of charge current. The voltage drop across the paralleling cables raised the voltage across bank two caused it to become overcharged and as a consequence cells 12 + 16 and 11 + 14 failed, suffering major swelling. Over time probably within the later half of their first year, the batteries in bank one would have begun to deteriorate with sulphation and with their internal resistance rising this exacerbated the plight of those batteries in bank 2.

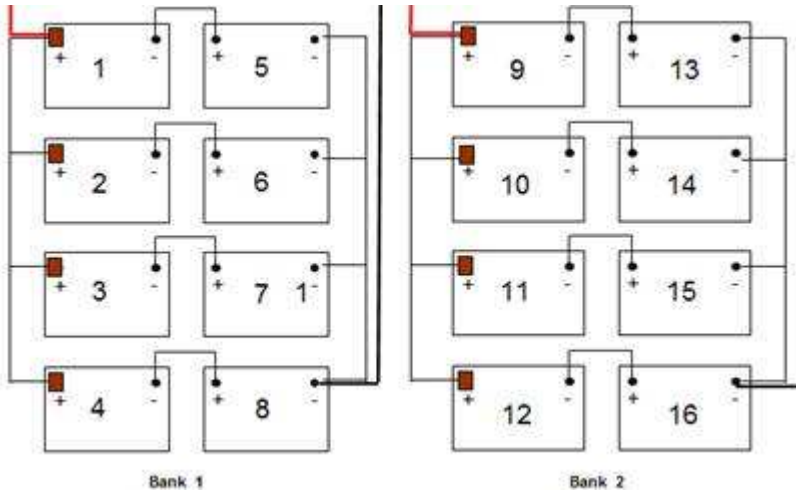
Out of the remaining batteries, four were chosen from bank 1. The top two sets in the parallel string battery Numbers 1&5, 2&6. See Fig 2

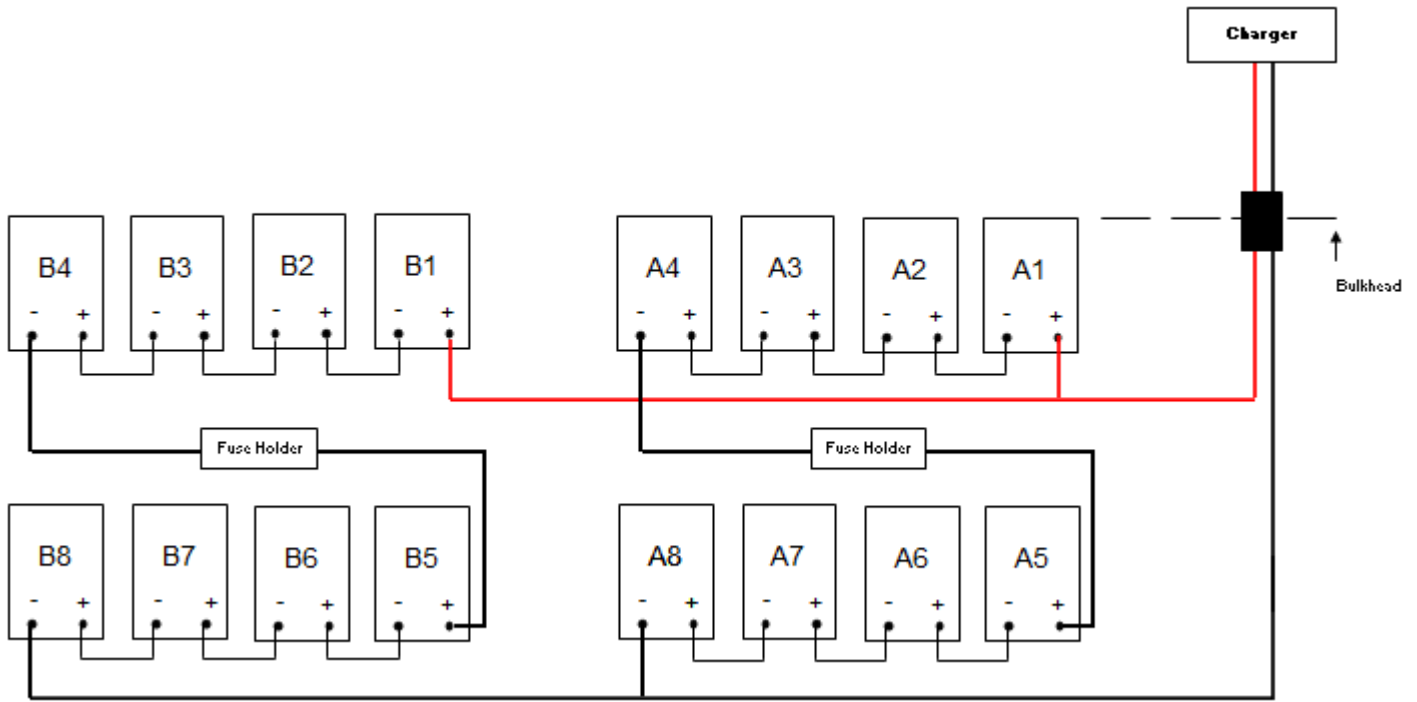
Fig 5

Between the top and bottom banks two long harnesses were used to interconnect each other to form the 100V string.

Bank A is the first point at which the charge is placed having for all intents no resistance. As bank B access's its charge a voltage drop in the harness raises the voltage across Bank A eventually leading to overcharge and an undercharge on Bank B, similarly the long interconnecting cables introduced between each bank will have the same effect eg, A1 – A4 will receive more charge than A5 – A8

This refuge has been reconfigured – and will be monitored for performance over a two year period. When installing the new batteries – the float voltage was increased to 110V for 24 hours before reducing it back to 107.5V. All the batteries with the exception of A6 equalised out and this will be closely monitored.
