**Why batteries used in Underground Safety Refuge Chambers fail prematurely**

**Case Study** - MinaArc 1367 Safety Refuge

**Case Study** – Strata 12 man Refuge Chamber

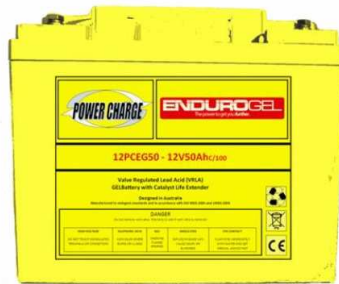
In February 2012 we were approached to source batteries for use in underground refuge facilities. We were provided with a photo of the sample (see below) and was told that this sort of problem was common in all refuges. At first glance it looked like the batteries had been overcharged but without visiting site to inspect the facilities there was no concrete reason to suspect this, as the prevailing opinion was that high operating temperatures was the probable cause the batteries where failing. We began by looking at alternative battery types eventually settling on the EnduroGel from Power Charge. This decision was made on the basis of its higher tolerance of temperature, its "Catalyst" technology, longer design life and because it came highly recommended. We supplied the Enduro's for a couple of years without any feedback and assumed the change had been positive for the mine and was were surprised when in early 2015 we received a call from the mine querying the quality of the Enduros because of their high premature failure rates. The Enduro's had suffered the same fate as their predecessors but at a faster rate and we became suspicious of the refuges charging systems. It was only after we began supplying another mine with batteries that we realised there was a serious problem with how the electrical system had been set up in the Refuge Chambers. Recently we have had the opportunity to investigate.

Destroyed Battery

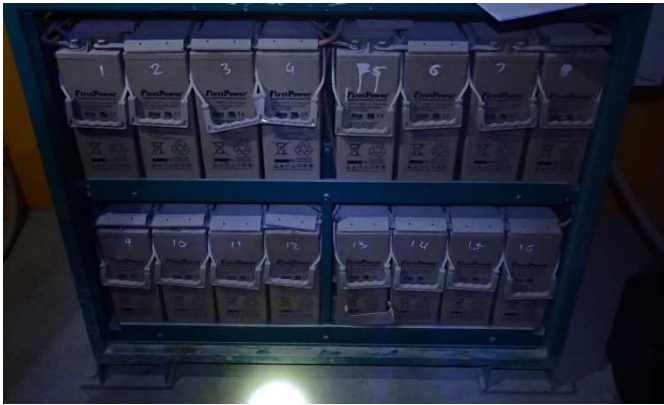
This refuge had two banks wired for 100 volt operation. They were stored on two shelves similar to the example below

Between the top and bottom banks two long harnesses were used to interconnect each other to form the 100V string.

Analysing the batteries, it was found that none could be recovered, all had very high impedance measurements and all had evidence of swelling – some more than others. Temperatures varying between 20-26 degrees C is unlikely to be a contributor to the failure of these batteries as is the charging voltage which was set at 108 Volts.

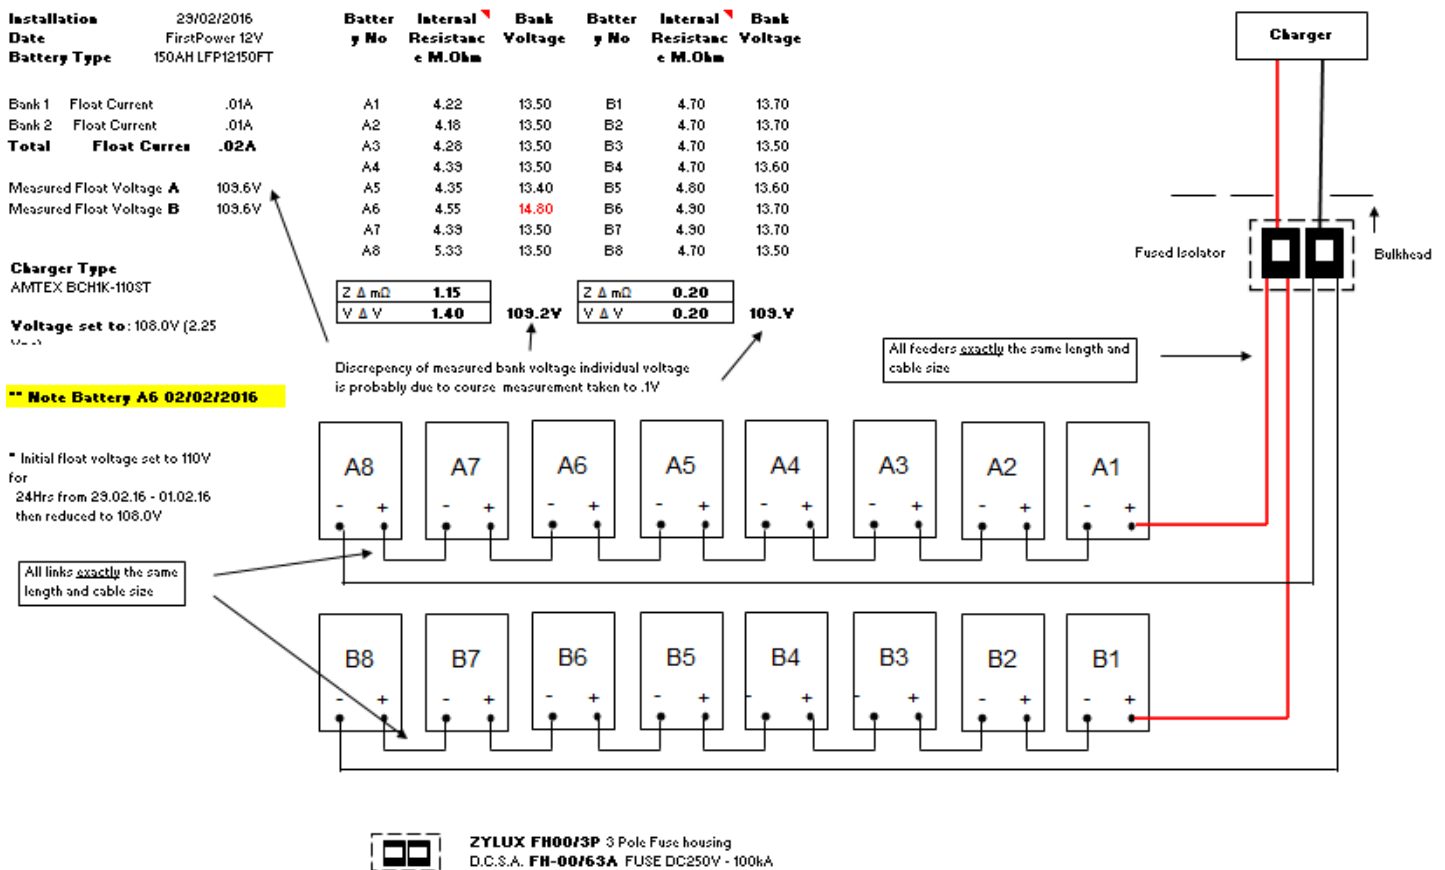
Without knowing the complete history of these batteries it is extremely difficult to conclude that the harness alone is the cause of the failure.

This refuge has been reconfigured – and will be monitored for performance over a two year period. When installing the new batteries – the float voltage was increased to 110V for 24 hours before reducing it back to 107.5V. All the batteries with the exception of A6 equalised out and this will be closely monitored.
